# POTASSIUM CORROSION TEST LOOP DEVELOPMENT

Quarterly Progress Report No.10 For Quarter Ending January 15, 1966

prepared for NATIONAL AERONAUTICS AND SPACE ADMINISTRATION Contract NAS 3-2547

SPACE POWER AND PROPULSION SECTION
MISSILE AND SPACE DIVISION
GENERAL ELECTRIC
CINCINNATI, OHIO 45215

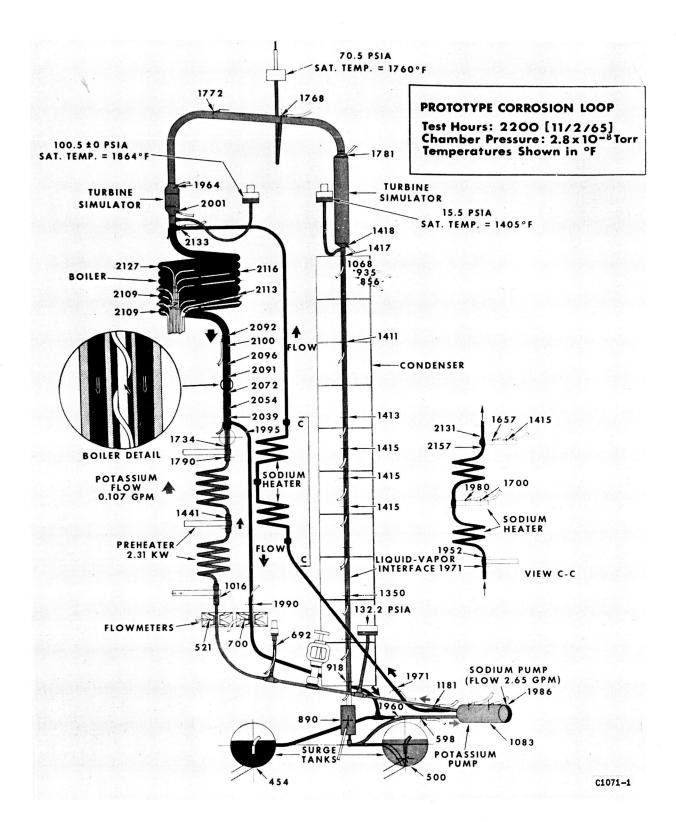
Loop operation during this period continued to be extremely stable with no significant fluctuations in pressure, temperature or flow in the two-phase potassium circuit during normal operation. The most important test conditions are summarized in Figure 1 which is data taken after 2,200 hours of operation and is typical of the loop conditions during the entire test as no significant drift or change of any of the temperatures or flow in either the sodium or potassium circuits has been detected. An analysis of the boiler performance after 259 hours of operation was given in the previous progress report (1) and the performance has not changed significantly during the subsequent 3,550 hours of operation. Several minor "incidents" which affected loop operation for brief periods occurred during the last quarter and these events are discussed below. An extended discussion of the test shutdown on January 8, 1966 which was necessitated by a water-to-vacuum leak in one of the test chamber cooling channels will be given in Section B of this report.

Figure 1. Prototype Corrosion Loop Test Conditions. (CDC4506)
